Rangeland Resources & Best Management Practices Review - Targhee NF

Allotment: Ripley Butte C&H Allotment **Forest/District:** Caribou-Targhee NF, Ashton-Island Park

Date: 9/2/2010

Unit Reviewed: Tom's Creek **On Date(s):** 7/11/2010 **Off Date(s)** 8/21/2010
Numbers: 465 cow/calf pair

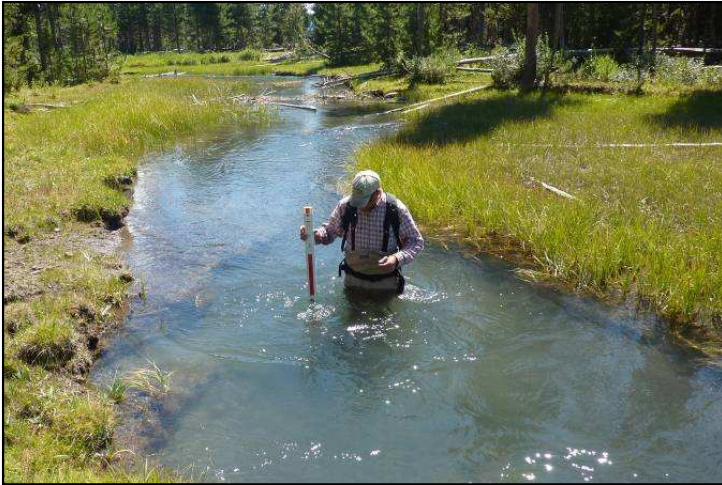
Photo 2. Tom's Creek in the State Unit of the Tom's Creek Allotment (photo 8/16/2010).

The nature of Tom's Creek is dynamic throughout its length (Gillilan 2010). From its source and through the upper portion of the Tom's Creek Allotment, the creek has a fine gravel bed (Photo 2). As the stream descends through the Tom's Creek Allotment and enters the Ripley Butte Allotment, stream conditions degrade. Specifically, the stream bed transitions to sand/silt dominated and the channel width/depth ratio increases (wider & shallower) with limited fish habitat and channel diversity. These conditions extend downstream through the Buffalo Allotment until the stream reaches an ungrazed reach near its confluence with the Buffalo River.

Stream conditions appear to be a function of grazing duration. Tom's Creek is in Proper Functioning Condition (PFC) within the State Unit of the Tom's Creek Allotment where livestock graze for 5 days. Tom's Creek is Functioning at Risk within the Lower Unit of the Tom's Creek Allotment where the grazing duration is 22 days. Tom's Creek is in poorer condition and rated as Functioning at Risk throughout the Ripley Butte Allotment where grazing duration is approximately 44 days. In addition to current grazing, there are several historical influences along Tom's Creek. An old breached earthen dam, the historic railroad grade, and historical grazing also play a part in the conditions found along the stream in the Ripley Butte Allotment.

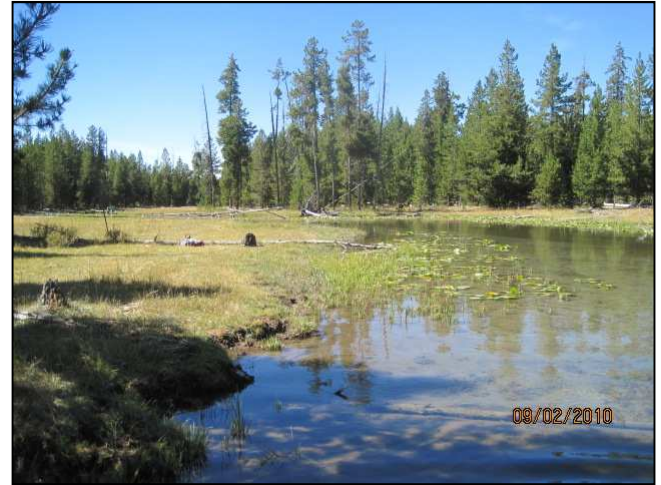
Photo 3. Tom's Creek in the Ripley Butte Allotment. Notice fine sediment bed and high width/depth ratio.

Part of PFC is to provide habitat for fish, waterfowl, and overall biodiversity. Characteristics that provide for fisheries habitat do not exist due to the over-widened stream that limits sediment transport and fails to produce clean gravels necessary for biotic diversity (Photo 3). Willows along the stream, where present, are severely hedged and dwarfed. These willows provide no cover or structure (Photo 5). The stream in its present state is a C5 Rosgen stream type, which is rated as having a very high sensitivity to disturbance (Rosgen 1996).
